Monochromator Vibration: Two case studies

Curt Preissner, Barry Lai, Alan Kastengren, and Mark Erdmann

Mechanical Engineering and Design Group
Advanced Photon Source
Argonne National Laboratory

MEDSI 2014, Melbourne

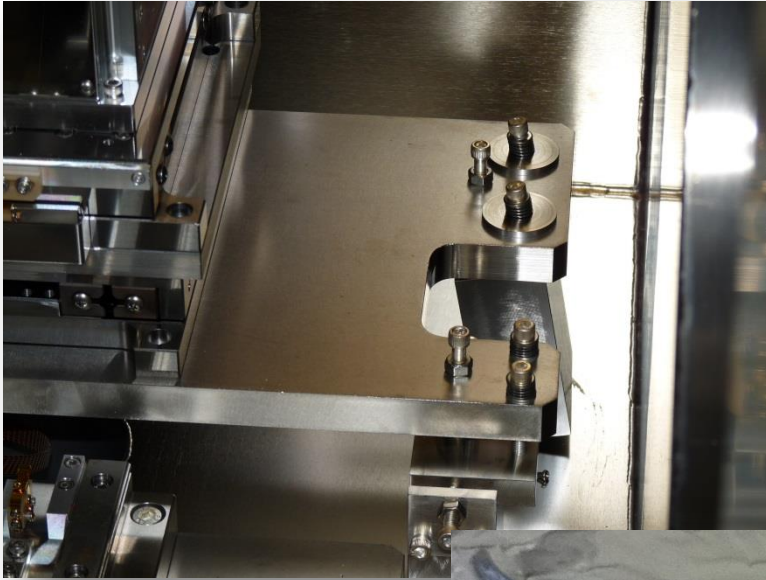
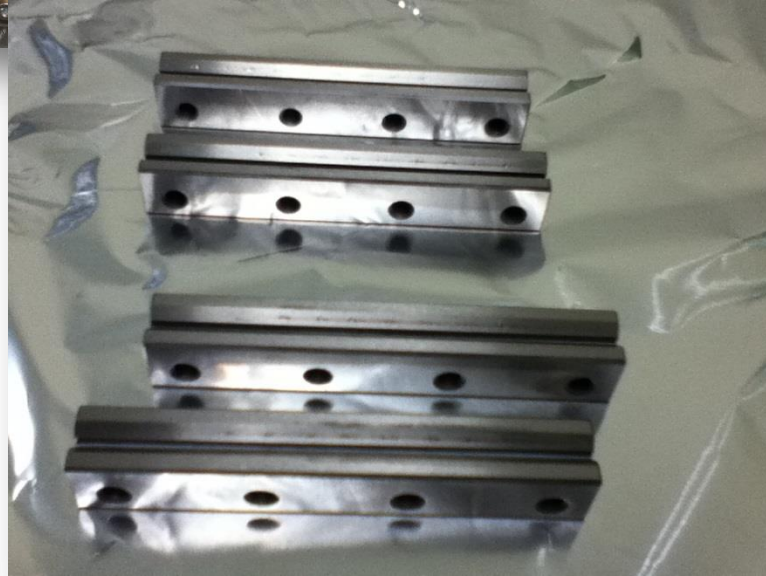
- Initial beam characterization was misleading
 - Camera frame rate was insufficient
 - Operational conditions were be different than conditions when imaging beam vibration were different than when measuring vibration
 - A roughing pump was connected to an evacuated flight path in the next hutch
- A number of “mirages”
 - Missing fasteners
 - Broken/incorrect baseplate mounting
 - Damaged vertical stage, fretting
- Cycle times between measurements were long
- Access to internals was limited

Case Study 1: Mirages

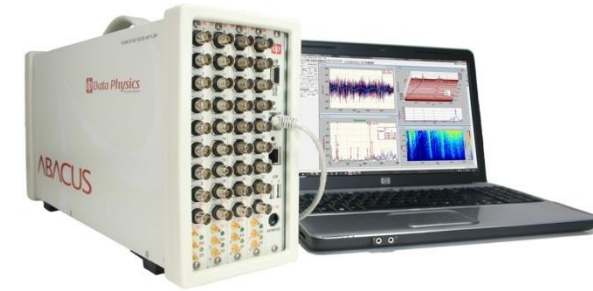
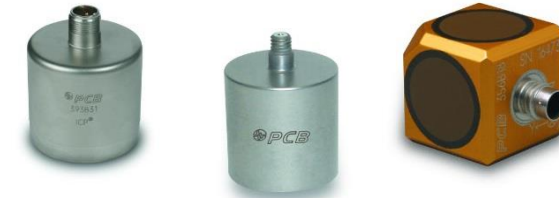
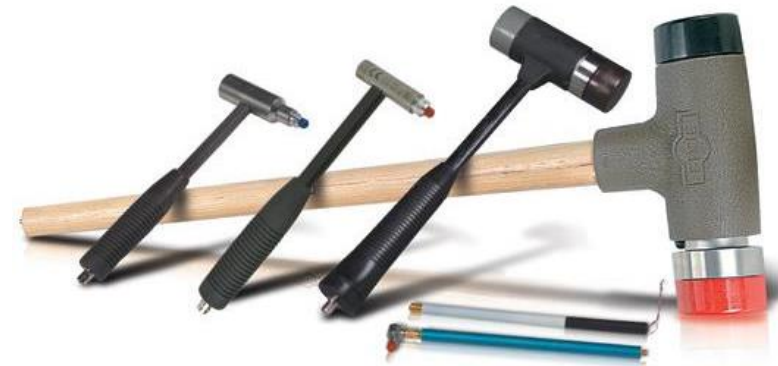
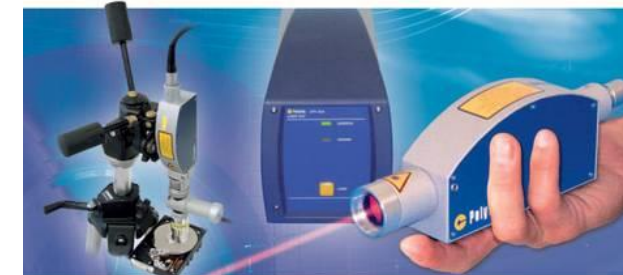
- Data Acquisition – Data Physics Abacus
- Accelerometers
 - PCB 393B31, single axis, 635 grams, 1 nm/√Hz @ 7Hz
 - PCB 393B05, single axis, 50 grams, 10 nm/√Hz @ 7Hz
 - PCB 356B18, triaxial, 25 grams
- Impact hammers
 - PCB 086E80, 4.8 grams
 - B&K 8202, 402 grams
 - PCB 086D50, 5.5 kilograms
- Polytec OFV-534 Laser Doppler Vibrometer
- Modal analysis can be used to estimate stiffness, and mode shapes (as opposed to operating shapes)
